Box 2.3: Flagship Home, Westminster City Council and Royal Borough of Kensington and Chelsea

- 2.21 With unlisted buildings of merit (and even with listed buildings, although obviously less so), there are certainly a range of different buildings and conditions, and there may also be opportunities for targeted upgrading of the building fabric in a manner that could contribute positively to the urban character whilst improving building performance in sustainability terms. There are increasing numbers of examples of good practice in this area (see Box 2.3).

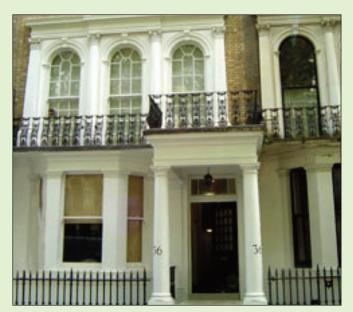
The 'Flagship Home', in Beaufort Gardens, Knightsbridge, is a model of sustainable refurbishment in a typical mainly residential conservation area in Kensington and Chelsea. It is also used as a model of good practice by the City of Westminster.

It is a five-storey Victorian terrace house in multiple occupation, typically found in central city conservation areas. It consists of 18 bed-sits and one self-contained flat, which accommodate 36 residents. The conversion involved creating a two bedroom self-contained flat with its own patio garden on the entire lower ground, the rental on which helps offset the costs of renovating the house.

Improvements cover lighting, heating, wall insulation, ventilation, glazing and appliances. They are intended to reduce energy costs by 67 per cent from approximately $\mathfrak{L}3,400$ to $\mathfrak{L}1,100$ per year, and cut CO_2 emissions by 63 per cent from 25.74 tonnes to 9.58 tonnes per year.

- Installation of energy efficient lighting. This has a longer life than normal GLS bulbs, and reduces the replacement as ell as running costs.
- A central gas-fired heating system with two communal condensing gas boilers.
- Insulated drylining (Conservation Area regulations restrict additional external wall insulation on the front and rear elevation).
- A new mechanical ventilation system, with efficient heat recovery overcoming any condensation and mould problems.
- Rear double glazed windows replacement and secondary glazing to the front windows.
- A-rated small refrigerators for all bed-sits and solar panels to the south-west rear of the building.

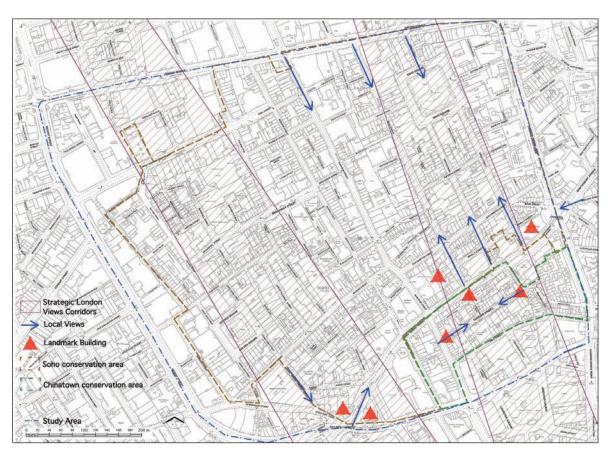
Figure 2.5: Local views and landmarks

- 2.23 Conversely poor quality shop fronts and signage are seen as detrimental to the character of the area. Although Soho has a wide variety of roof forms and materials, and these are often less visible, they are regarded as important in terms of their impact on views (see Figure 2.5). The Council is concerned to prevent excessive upward extensions that would undermine the largely uniform, mainly 4-storey character of the area. The Conservation Area Audit includes a map indicating buildings where upward extensions would be considered acceptable (see Figure 2.6).

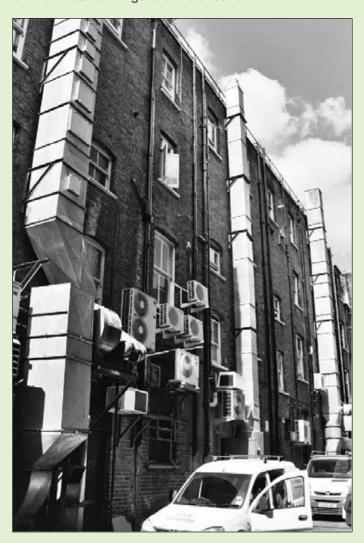
Throughout Soho there are many examples of poorly sited and highly visible external ducts, air-conditioning units, services and cables. Many of these are located on roofs or often in courts and alleys and have a significant and detrimental impact on individual buildings and the street scene.

Figure 2.7: Ducting has a significant impact on the courts and alleys of Soho and Chinatown

2.26 However, it is also the case that the backs of buildings are commonly already retrofitted to meet of growing environmental demands, in particular ventilation and cooling. The resulting clutter is highlighted in the Conservation Area Audit (see Box 2.4) and indicates the need for measures to rationalise external services on buildings.
