The art of concrete

BUILDING THE SOUTH BANK ARTS CENTRE

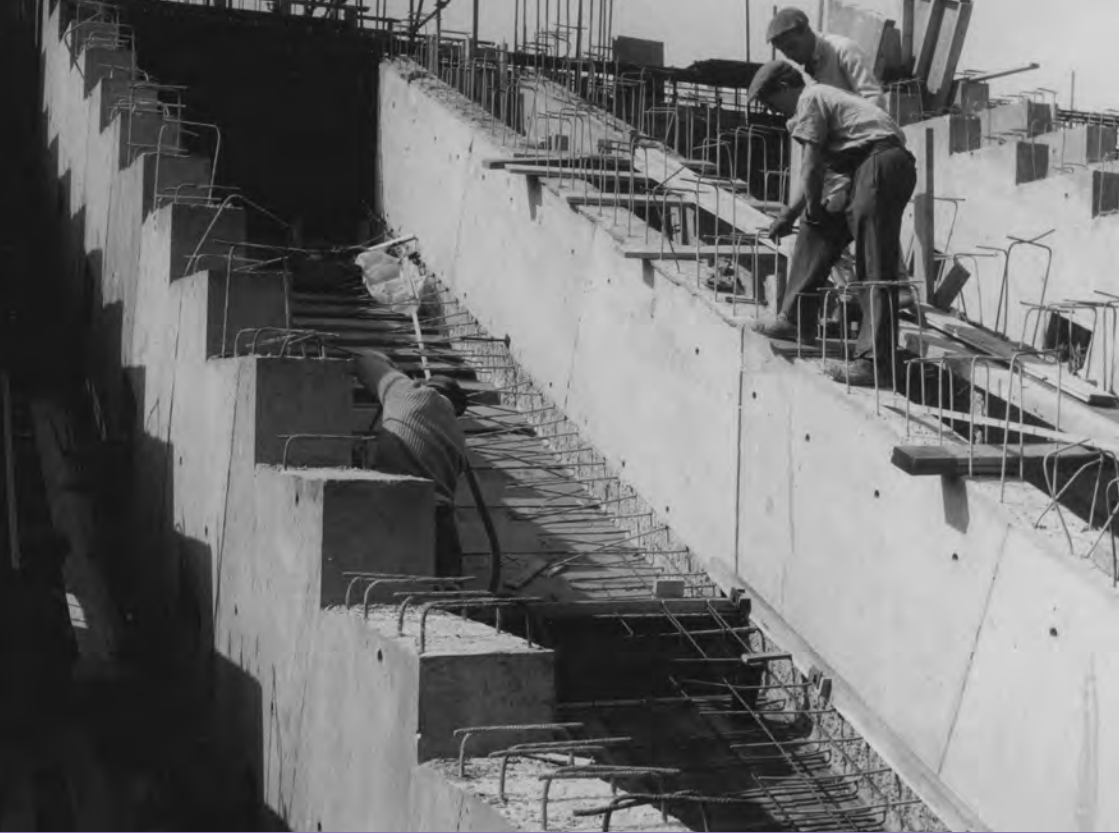
Front cover: Constructing the raked seating for the Queen Elizabeth Hall.
Source: Photograph courtesy of Rod Bond

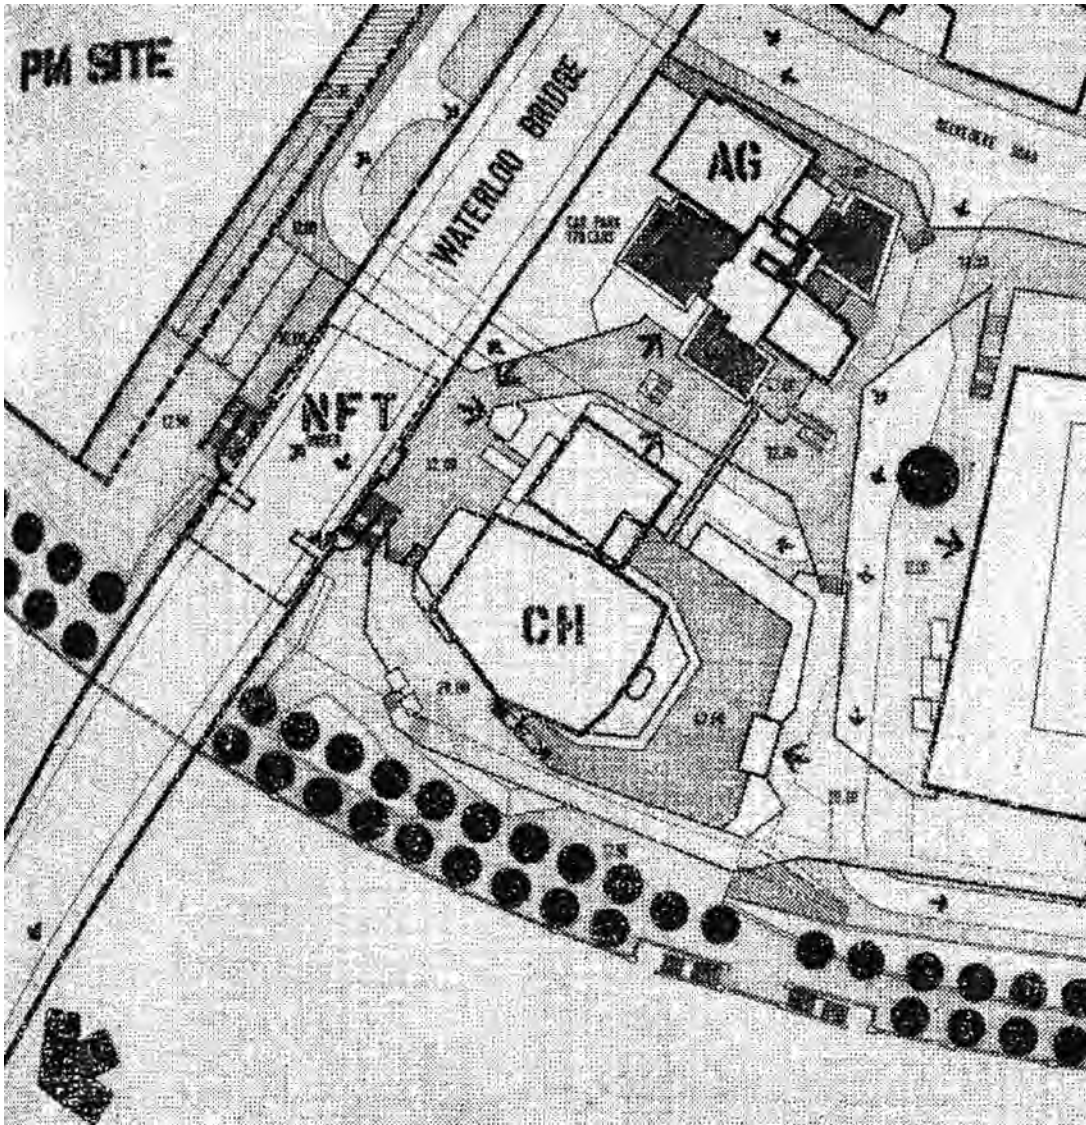
Site plan showing relationship of concert hall and art gallery to the Royal Festival Hall.
Source: *The Builder*, 13 July 1962, reproduction courtesy of *Building magazine*.

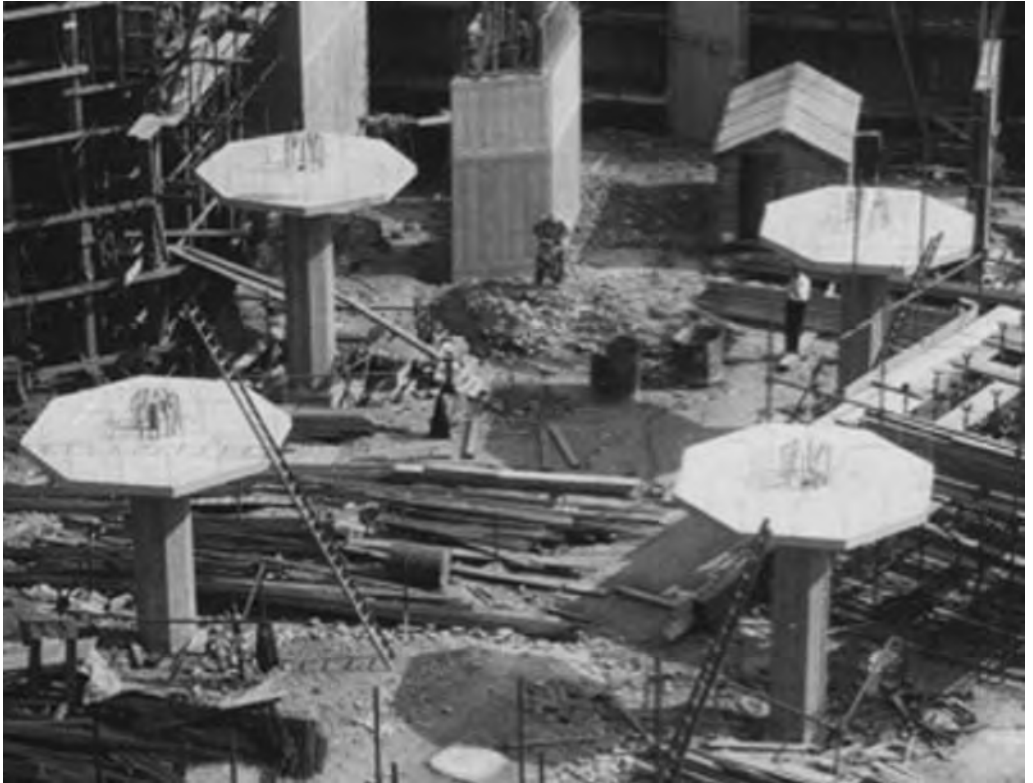
Mushroom columns. Source: Photograph courtesy of Rod Bond

The first part was that you put up these octagonal mushroom columns, and we were let it be known that there would be no making-good of concrete whatsoever, full-stop, that was it.

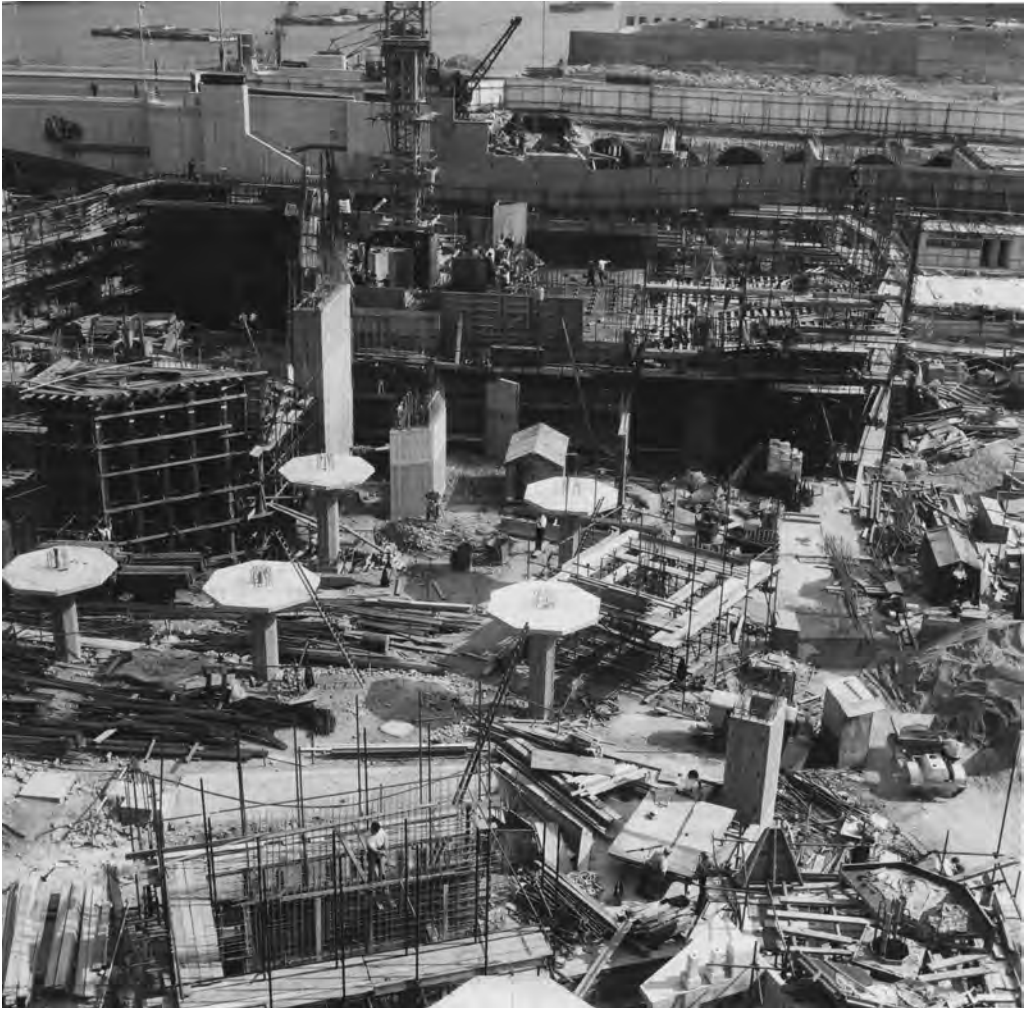
Early stages of construction.
Source: Photograph courtesy of Rod Bond

Building close to the edge of the River Thames had created problems for all the constituent buildings of the South Bank complex and, in the days before GPS, it was difficult to accurately centre the augers of the massive drills used. Inaccuracies in the positions of the piles were discovered, resulting in the placing of a complex series of beams to connect a number of the perimeter piles, which, in turn, caused a delay at the outset of the contract. Glan Davies remembered the unforgettable experience of descending inside one of these piles all the way to bottom.

Now, in excavation for the main building we had big pile-caps, very heavily reinforced, but underneath each pile-cap was a number of six-foot diameter piles that had been borne, drilled into the ground, to a depth of about 100, 120 feet, and they belled out at the base – they were 16 feet wide. And these were, as I say, six foot in diameter. And the engineer for the client, resident engineer, had to go down to the base of these piled areas that they'd drilled out to make sure ... where it had been built, it had opened out to a diameter of 16 feet, that it had all been cleaned out properly. And this engineer said to me, one day, "Davies," he said, "it's alright you doing the work – I'm the one that's taking

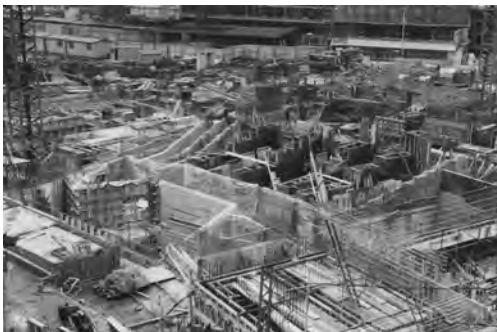
Early stages - curing concrete.
Source: Photograph courtesy of Rod Bond

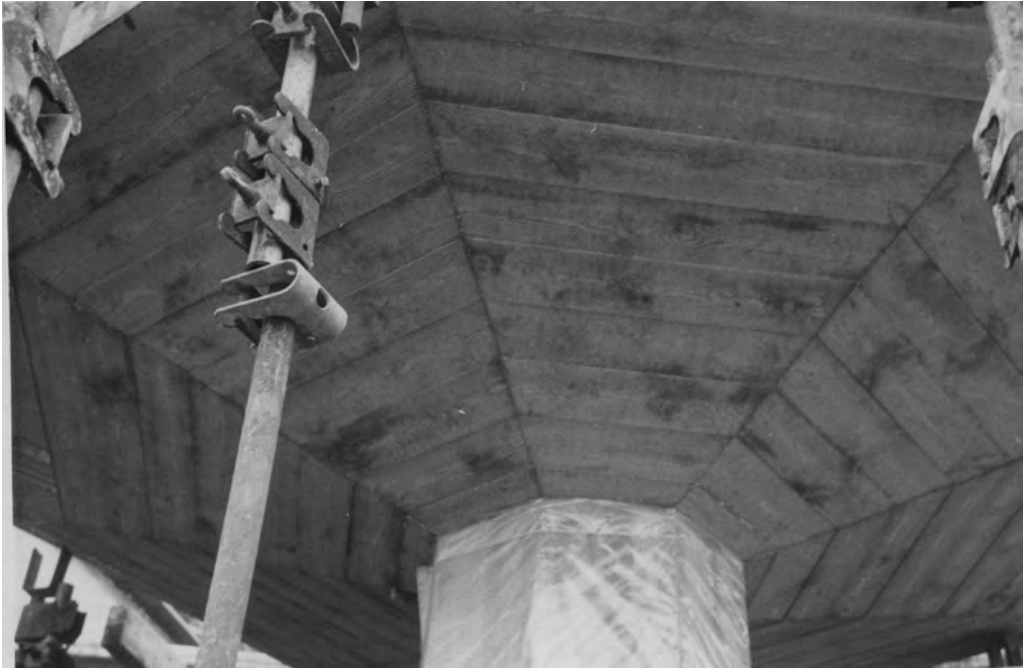
Mushroom column detail. Source: Photograph courtesy of Rod Bond

Everything was levelled and done within 5mm, which is a quarter of an inch. ... And that was done by a certain step on Waterloo Bridge, we made a datum, so that it would never be disturbed or whatever, and everything was levelled – the tops of a shutter being poured was levelled to within 5mm. And that is

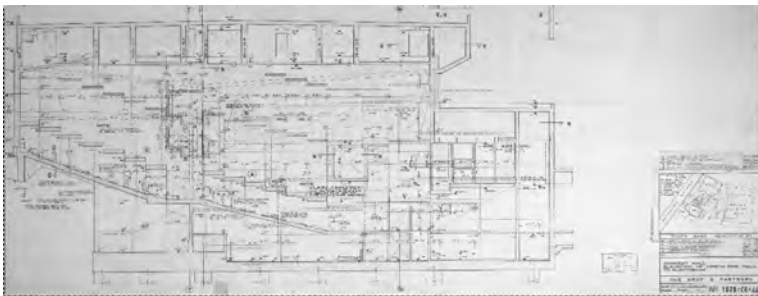
Engineer's Drawing of Queen Elisabeth Hall auditorium. Source: London Metropolitan Archives

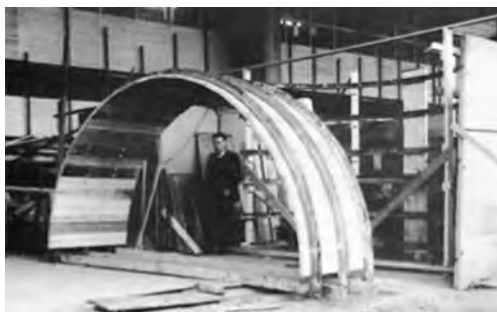
Formwork for spiral staircase. Source: *Crown Journal*

Peter Day recalls this requirement that some timber was one inch and a half, whereas other boards were one inch and five sixteenths thick (or one inch and three eighths, according to an article in *Construction News* at the time) in order to form the distinctive, uneven, textured surface of the concrete⁴². In some cases, such as in the foyer area to the concert hall building, the formwork involved placing cardboard boxes within the beams 'to provide a hollow, weight-saving, form of construction'.⁴³ Concrete was then cast in two pours for each beam. The 17 feet mushroom-shaped columns in the same area, on the other hand, were cast complete in one pour, including the cap.⁴⁴

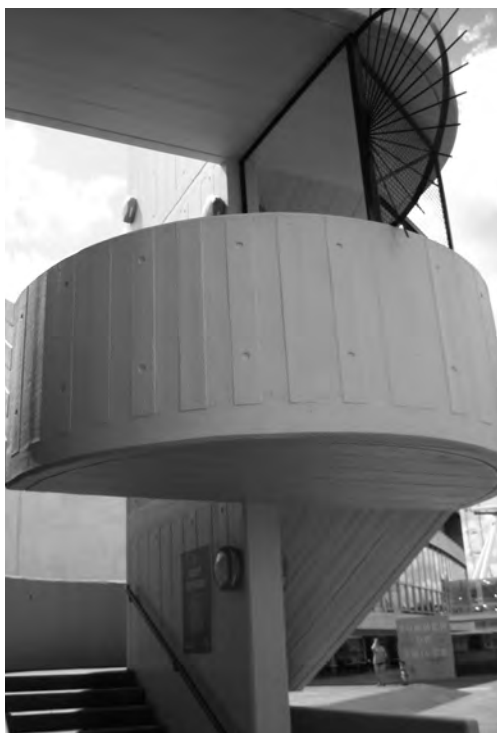
Painted external staircase in 2012.
Source: Photograph courtesy of Christine Wall

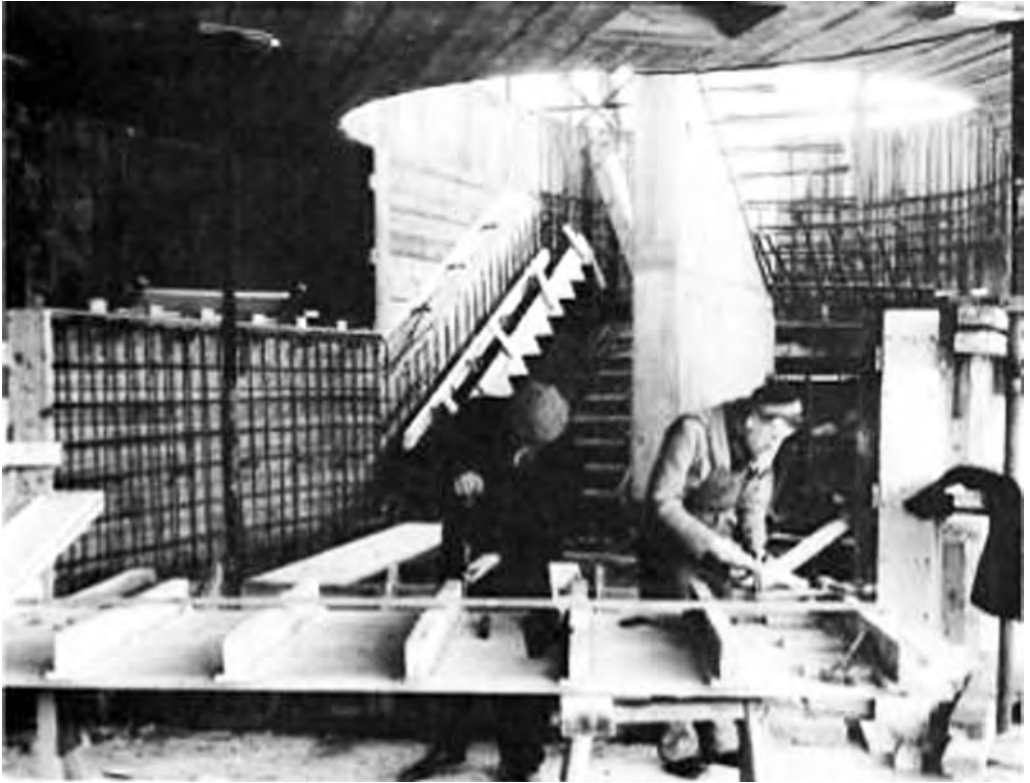
Carpenters working on site on formwork. Source: *Crown Journal*

Forms were re-used, sometimes as many as 12 times,⁴⁷ and at least six or seven, according to Rod Bond. However, in order to remove the forms without spoiling the finish, they had to be dismantled board by board. After removal, the boards went back to the workshop for cleaning; all the concrete had to be rubbed off before they could be used again. Approximately 50 per cent of the timber was discarded because of the bolt-hole positions, the column shutters being the exception since they did not contain bolts. The best patterning was apparently achieved after three or four uses of the formwork when

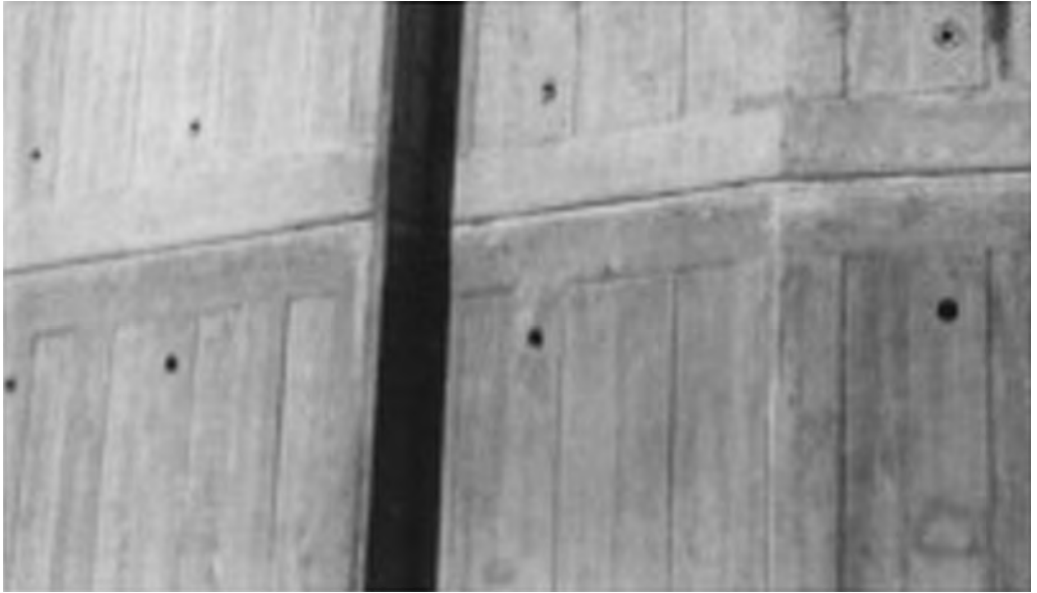
Concrete finish showing position of bolts. Source: Photograph courtesy of Rod Bond

all the whiskering (loose timber fibres) was gone.⁴⁸ In total, more than 250,000 items of concrete hardware were listed in the contract. This included a system, developed by Higgs and Hill and much praised by *Construction News*, consisting of mild steel 'U' channels that were bolted to the ply shutters. The channels 'were held away from the concreted walls with greased mild steel rods that could be blocked to the required gap width, and easily withdrawn to allow striking'.⁴⁹

This system of 'U' channels was devised by Glan Davies on the construction of the Purcell Room and he described it in precise detail many years later when interviewed in 2012.

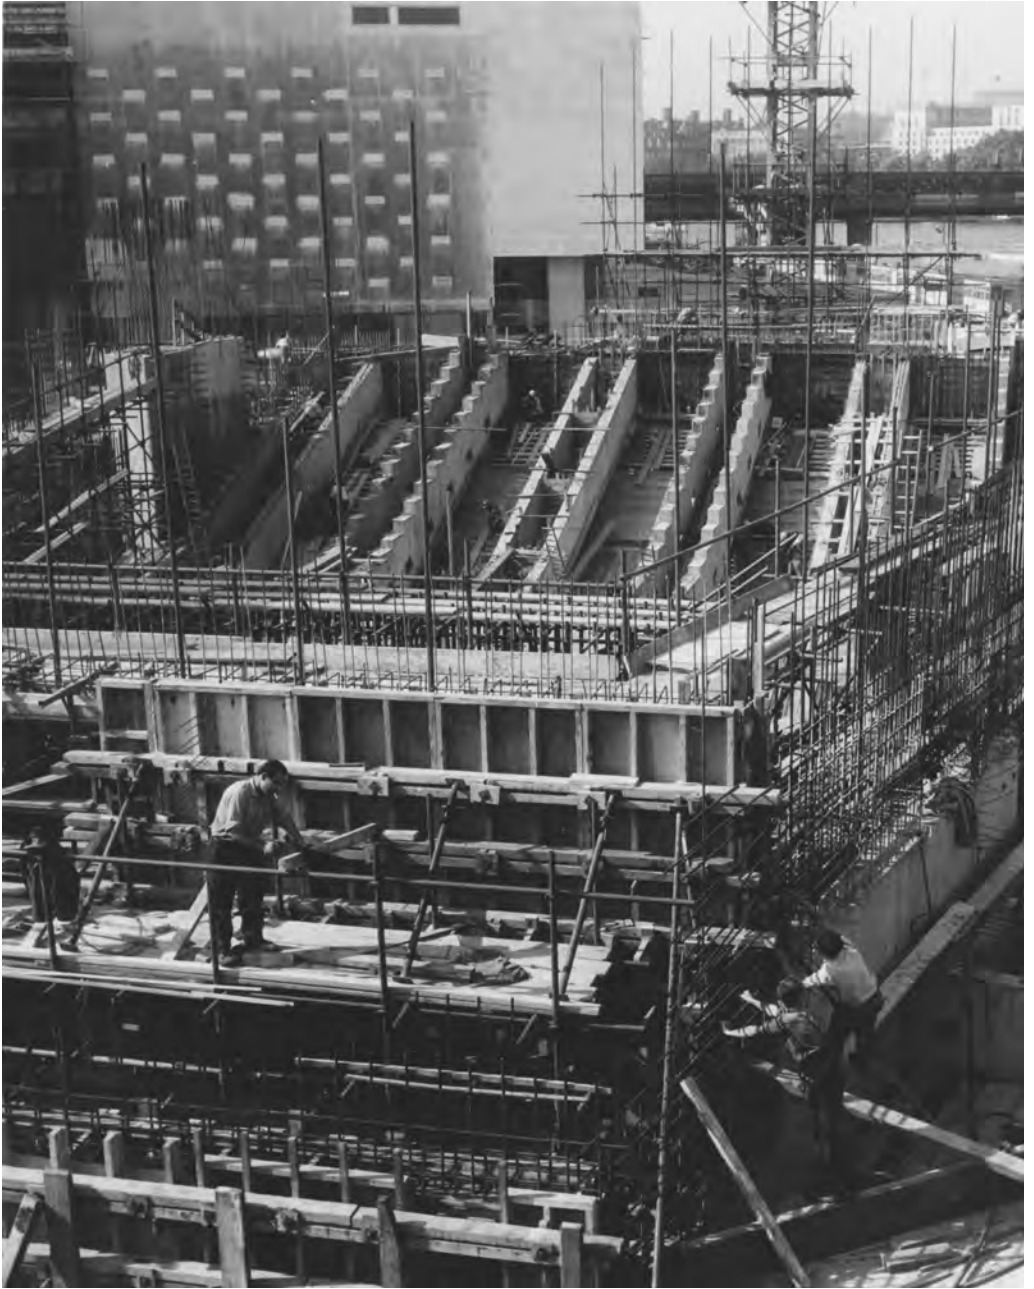
Formwork on the Queen Elizabeth Hall. Source: Photograph courtesy of Rod Bond

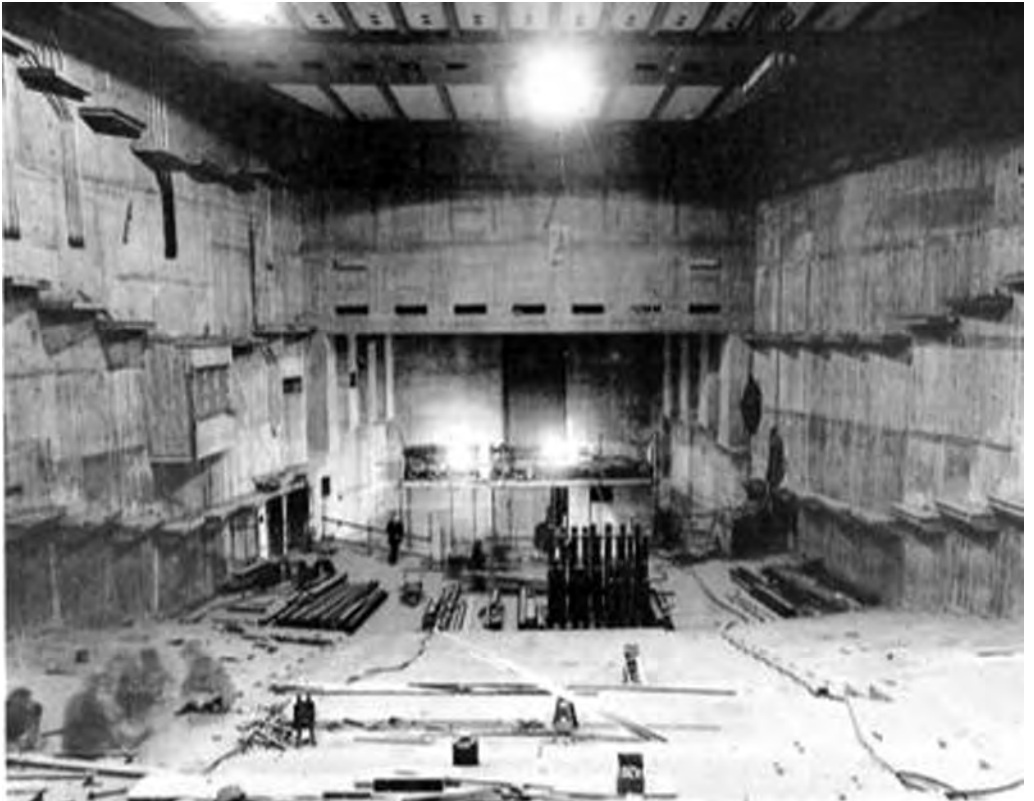
Interior of QEH auditorium. Source: Crown Journal

Now the Queen Elizabeth Hall was a vast concrete structure, and the whole of the underside of the Queen Elizabeth Hall was built on a cantilever basis, and it was laid down and supported on some...temporary steel structures, some tubular, some steel-framed, and, first of all, we built the columns up to it, and then we built the auditorium floor,
